RESIDENTIAL INSPECTION FROM HERCULES HOME INSPECTIONS

123 Sample Street
DEMO CITY, ST 12345

3/12/2026 9:04AM

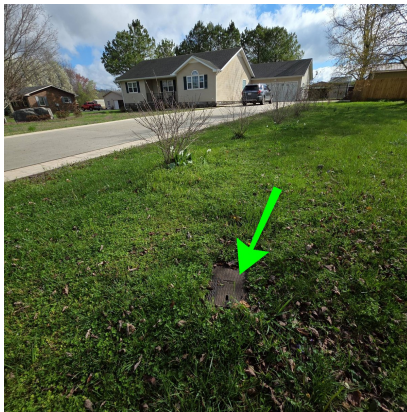
2.1.1 Water Shutoff Valve Location: At meter by road, Cover difficult to remove, tool needed, Cover difficult to remove, tool needed, Cover difficult to remove; tool needed

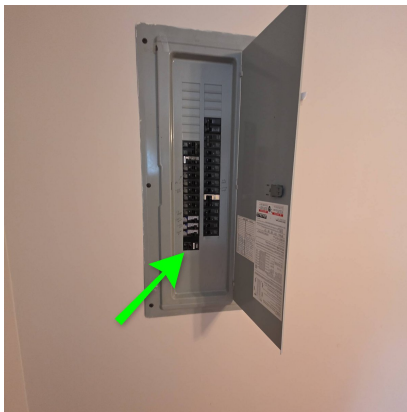
2.1.2 Main Electrical Service Disconnect Location: At Main Breaker in the Electrical Panel

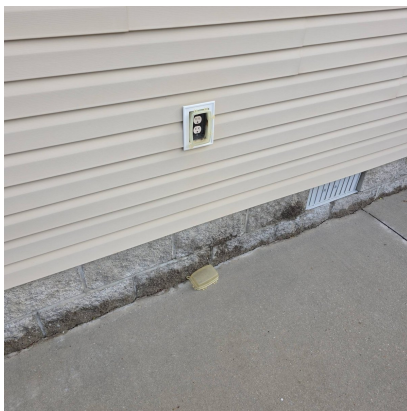
4.3.3 Weatherproof Exterior Outlet Cover Damaged !

The weatherproof cover at an exterior electrical outlet was damaged. This condition can allow moisture to enter the outlet, creating a potential electrical hazard. I recommend having a qualified electrician replace the damaged cover to ensure proper weather protection and safe operation.

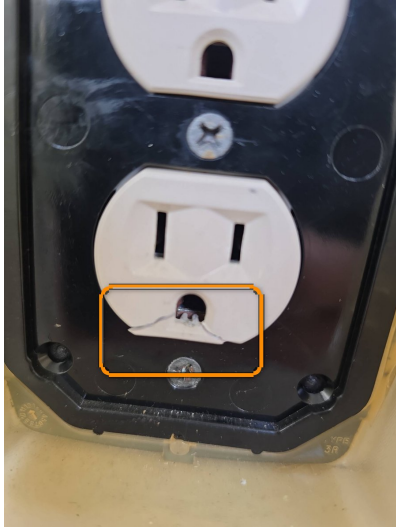
4.3.4 Outlet Broken !

The receptacle on the front porch has a broken lower edge. This can expose internal components and increase the risk of electrical shock or damage to the outlet. I recommend replacement of the receptacle by a qualified electrician.

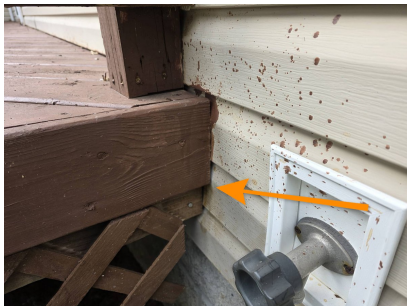
4.5.2 Improper Deck Attachment To Home

The back deck ledger board is installed over the vinyl siding rather than being properly flashed and attached directly to the structure. This is an improper installation that can allow moisture intrusion and potential structural issues over time. Although no movement was observed and it appears to have been in place for years, I recommend evaluation by a qualified contractor and correction if needed.

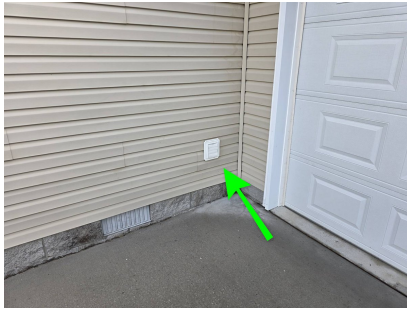
4.8.1 Location of Dryer Exhaust Vent: By garage vehicle door

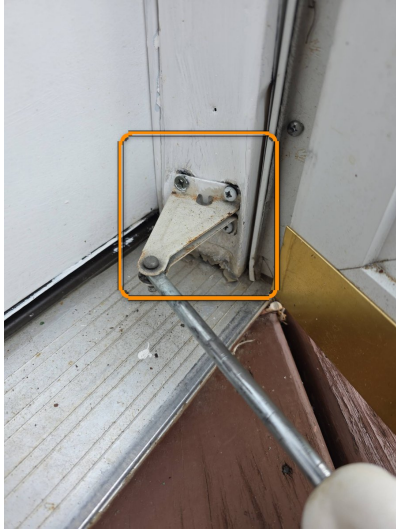
4.9.2 Bent/Loose Trim

The trim/cover on the door frame between the back door and storm door is bent and not securely fastened where the storm door closer attaches. This can prevent the storm door from operating properly and may allow the attachment point to loosen further over time. I recommend repair or reinforcement by a qualified contractor to ensure the storm door is securely supported.

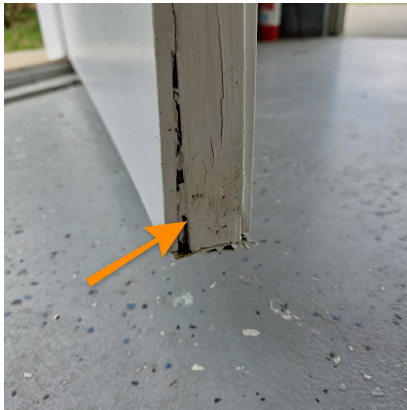
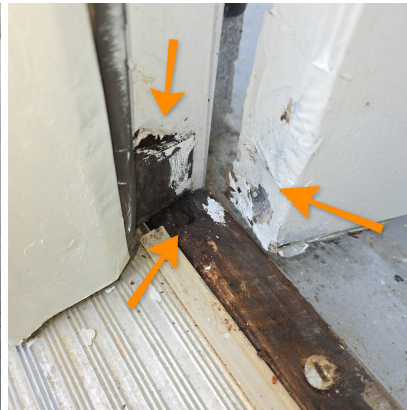
4.9.3 Water Damage At Exterior Door

Water damage is present at the threshold, door, and lower frame of the side garage door. Some areas on the door appear to have been taped and painted rather than properly repaired. This condition can worsen over time and allow continued deterioration of the door components. I recommend repair or replacement of the damaged materials by a qualified contractor.

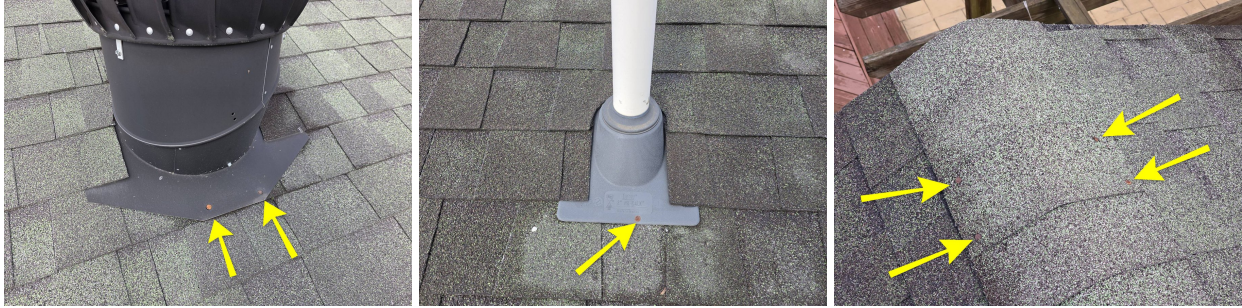
Nail heads are exposed at the roof turbines, plumbing vent pipe boots, and ridge cap shingles. Exposed fasteners can allow water intrusion and lead to roof leaks over time. I recommend sealing the exposed nail heads with an appropriate roofing sealant to help prevent moisture entry.

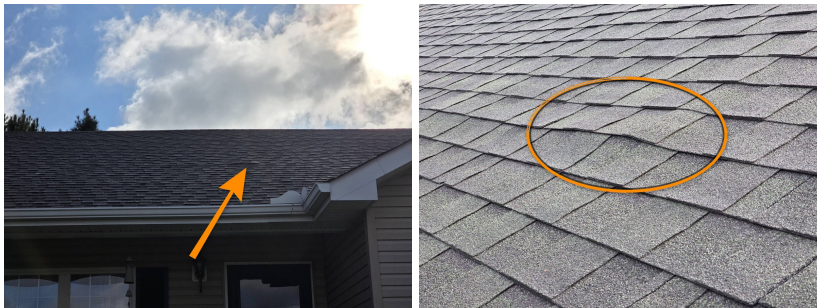
5.1.4 Raised Spot On Roof

A raised area was observed on the roof surface above the front door. The corresponding attic area was not accessible during the inspection due to insulation covering the attic floor, so the cause could not be determined. I recommend further evaluation and repair as needed by a qualified roofing contractor.

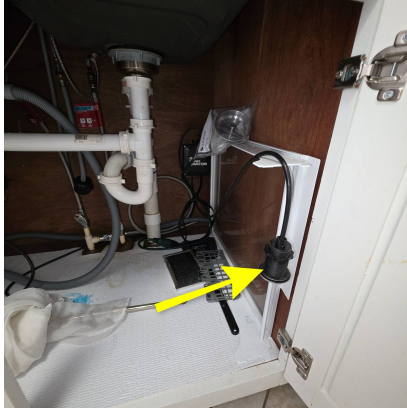
The garbage disposal control device was not properly mounted and was lying loose inside the sink base cabinet. This is an improper installation and could be damaged or accidentally operated. I recommend having it properly secured and mounted.

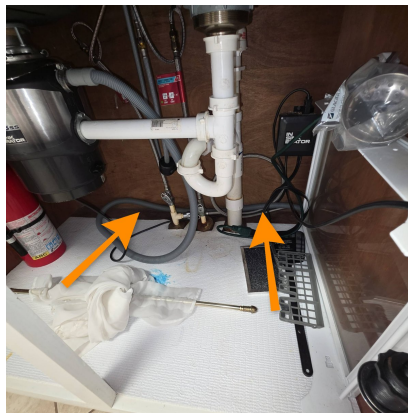
6.4.2 Missing High Loop

A high loop is necessary to prevent cross connection in the event that the sink discharge runs to the dishwasher discharge. A high loop is just as it sounds, the waste line is peaked as to resemble a roller coaster to create what is called an air gap. That air gap will help prevent the back flow of waste water into the dishwasher if the sink's waste lines become clogged.

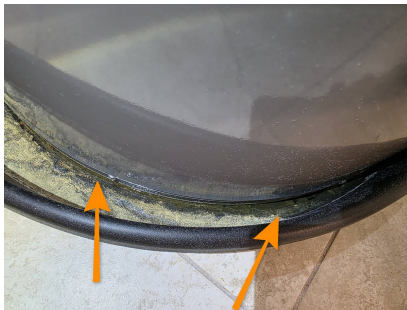
Water was observed in the water heater drain pan at the time of inspection. The source of the water was not determined, and the water heater was a newer unit manufactured in 2025. Water in the drain pan can indicate an active leak from the water heater or associated plumbing components, or it may be the result of a past event, but continued moisture can lead to corrosion, damage to surrounding materials, or eventual failure of the unit. I recommend monitoring the area for additional water accumulation and having the water heater and related connections evaluated by a qualified plumber to determine the source and make repairs as needed. (This observed moisture had dried up by the end of the inspection.)

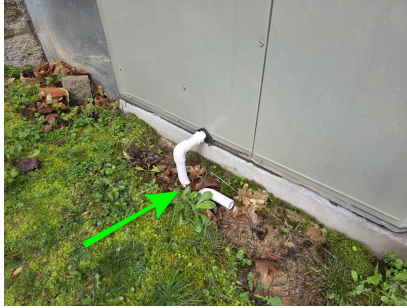
9.6.1 Condensate Discharge Confirmed

I observed a discharge pipe apparently connected to the condensate drain installed at the cooling system.

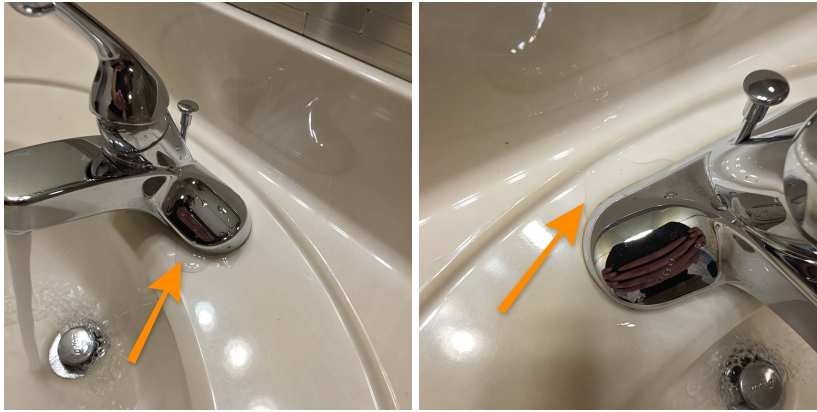
The bathroom faucet handle leaked when opened fully, indicating wear or a defect. I recommend having a qualified plumber repair the faucet.

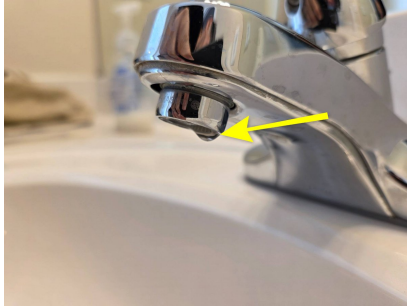
A slow drip leak was observed at the bathroom sink faucet (before I ran any water here). Even minor leaks can waste water and lead to fixture wear over time. I recommend repair or replacement of the faucet as needed.

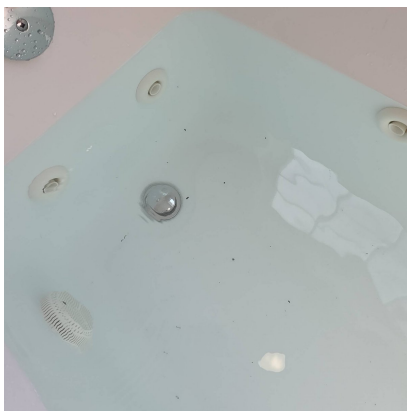
Debris was observed discharging from the hydromassage tub jets when they were operated. This condition is consistent with buildup that commonly occurs when whirlpool tubs are not used frequently and can affect water quality and proper jet operation. I recommend cleaning and flushing the jet system in accordance with the manufacturer's instructions prior to regular use and periodically thereafter to reduce buildup and maintain proper performance.

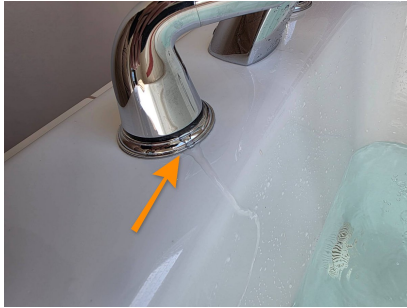
11.3.3 Leak At Supply Handle

A leak was observed at the tub supply handle. Active leaks can lead to moisture damage and potential mold growth if not addressed. I recommend repair by a qualified plumber.

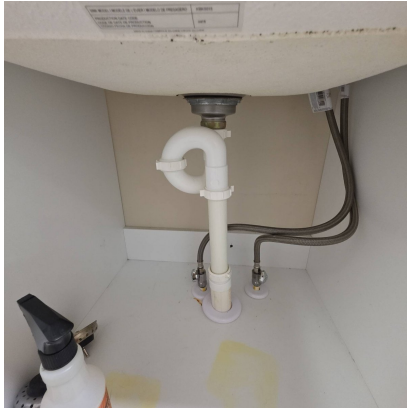
An S-trap configuration was observed under the laundry sink. S-traps are prone to siphoning, which can allow sewer gases to enter the living space. I recommend replacement with a properly vented P-trap by a licensed plumber.

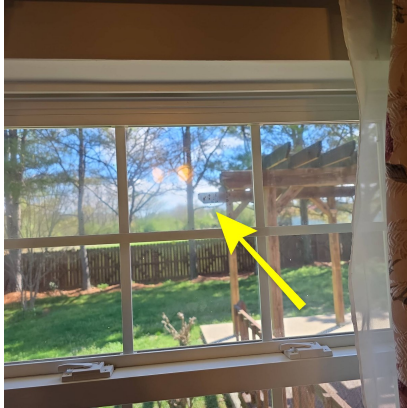
Location: Back left bedroom

One or more windows appeared to have a failed seal, as evidenced by visible fogging between the panes. This can reduce visibility and energy efficiency, though it is typically a cosmetic issue. I recommend consulting a window professional to determine repair or replacement options.

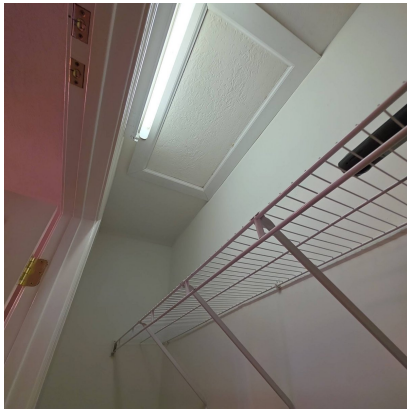
14.1.2 Attic Partially Inaccessible

The attic was partially inaccessible due to the location of the scuttle hole and shelving installed below it. I attempted to stick lights and cameras up into the space as best as I could, but there may be defects in the inaccessible areas that could not be observed during this inspection. This is a limitation.

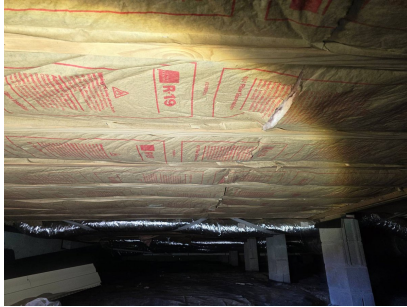
Batt insulation in the crawlspace is installed with the vapor barrier facing the wrong direction—downward instead of toward the heated living space. This improper installation can trap moisture against the subfloor, potentially leading to mold growth and wood deterioration. I recommend correction by a qualified contractor to ensure proper moisture control and insulation performance.

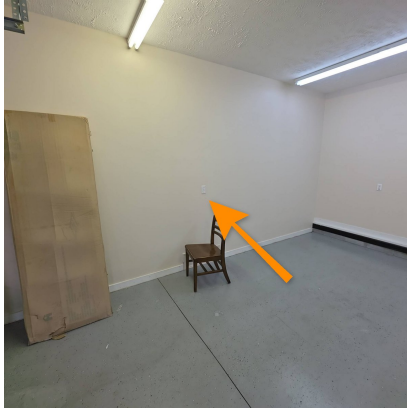
I observed a receptacle in the attached garage without GFCI (or ground fault circuit interrupter) protection.

GFCI protection is required for all 15- and 20-amp receptacles in a garage, including outlets for refrigerators, garage door openers, and washing machines.

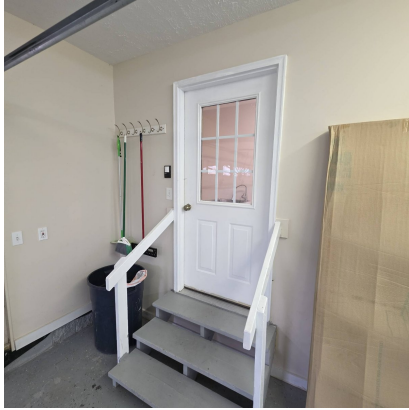
The door between the garage and the home's interior did not appear to be fire-rated. A fire-rated door in this location is an important barrier to limit the spread of fire and fumes into the living space. I recommend replacement with an appropriate fire-rated door by a qualified contractor.
