RESIDENTIAL INSPECTION FROM HERCULES HOME INSPECTIONS

123 Sample Street, Demo City, ST 12345

5/05/2026 9:14AM

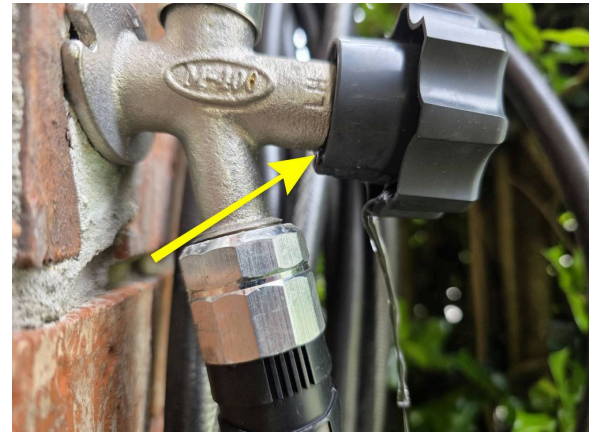
3.1.4 Spigot – Leaking At Stem

OBSERVATION: The exterior spigot was observed leaking at the stem.

EVALUATION: This condition can waste water and may worsen with normal use over time.

RECOMMENDATION: I recommend repair of the spigot by a qualified plumbing contractor.

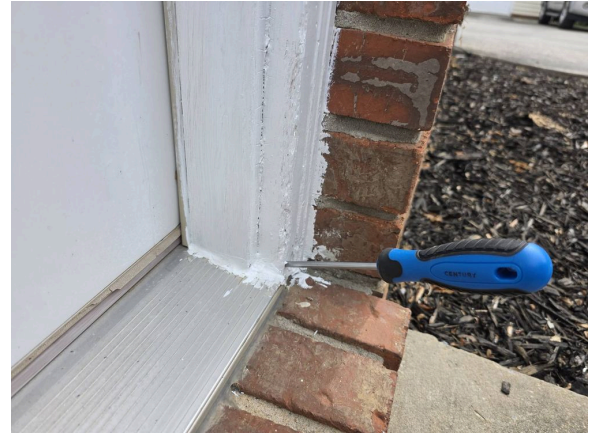
3.1.5 Exterior Door Frame – Wood Rot At Base

OBSERVATION: Some wood rot was observed at the base of an exterior door frame.

EVALUATION: Deteriorated wood can allow additional moisture intrusion and may affect the door frame's durability and proper function if not addressed.

Right end

RECOMMENDATION: I recommend repair or replacement of the damaged wood by a *qualified contractor* to help prevent further deterioration.

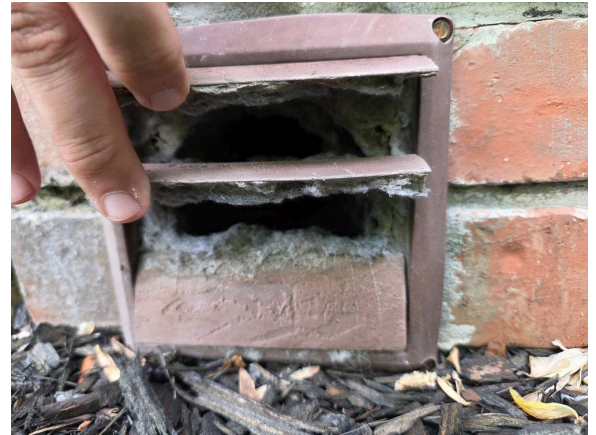
3.1.6 Dryer Exhaust Piping – Cleaning Needed

EVALUATION: Lint buildup in the exhaust piping can restrict airflow and reduce dryer performance, and it may create a fire hazard.

Location: Front

RECOMMENDATION: I recommend having the dryer exhaust piping cleaned by a qualified contractor.

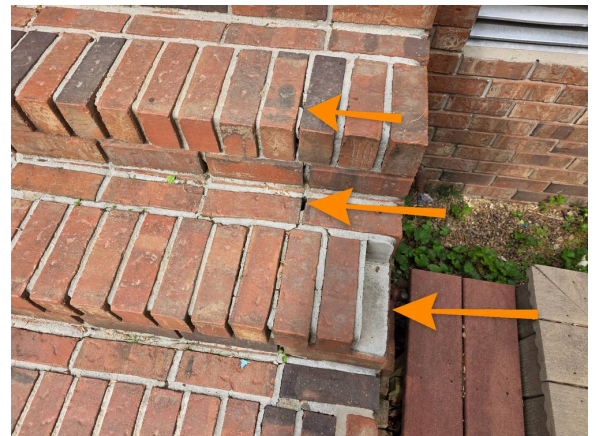
3.1.8 Back Steps – Missing Brick And Damaged Mortar

OBSERVATION: Missing brick and damaged mortar were observed at the back steps.

EVALUATION: This condition can reduce the stability of the steps and may allow further deterioration from moisture exposure and regular use.

RECOMMENDATION: I recommend repair by a qualified contractor to restore the damaged masonry and improve the safety and serviceability of the steps.

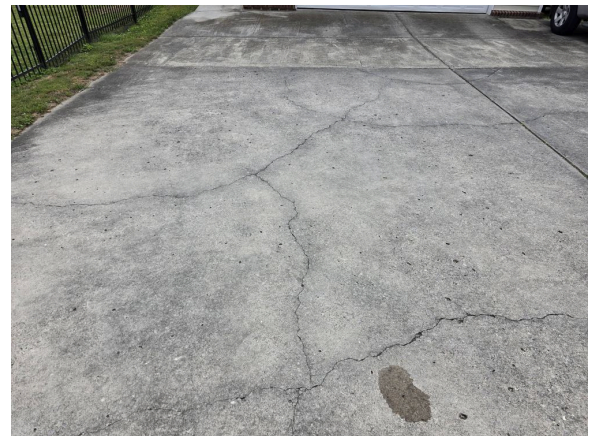
3.2.5 Driveway – Typical Cracking

OBSERVATION: Typical cracking was observed in the driveway surface.

EVALUATION: This condition is common with age and use, but cracks can allow water intrusion and may lead to further deterioration over time.

RECOMMENDATION: I recommend sealing and monitoring the cracks, and repairing them as needed to help limit further wear.

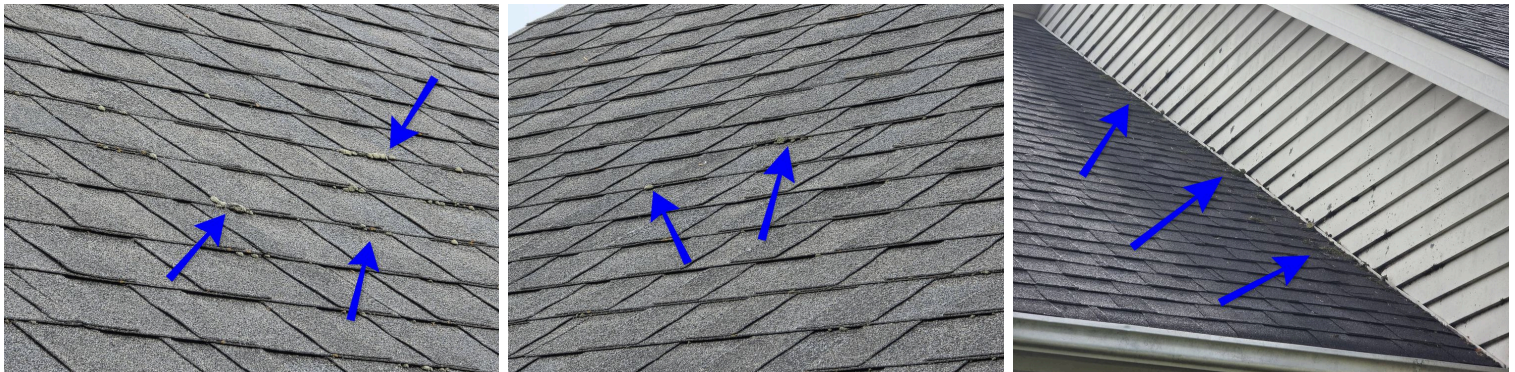
OBSERVATION: Moss growth was observed along some shingle edges on the roof.

EVALUATION: This condition can retain moisture and may accelerate deterioration of the roof covering over time.

RECOMMENDATION: I recommend having the moss removed and monitoring the roof for any related damage by a qualified roofing professional.

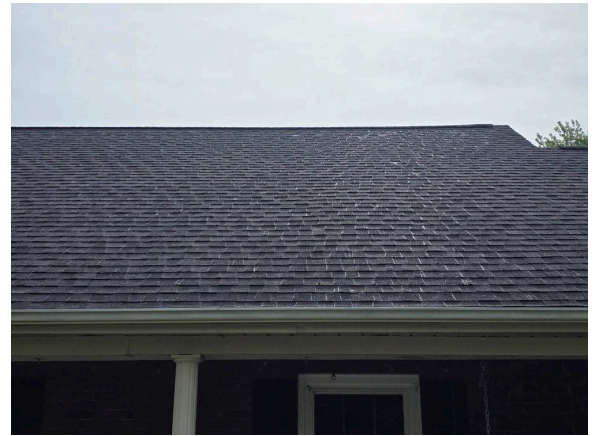
4.1.4 Roof Covering – Shiny Shingle Edges

OBSERVATION: Shiny edges were observed on asphalt shingles, indicating wear with the fiberglass mat exposed at the shingle edges as well as the face of some shingles.

EVALUATION: This condition indicates the shingles are aging and may be more vulnerable to accelerated deterioration and reduced weather protection.

RECOMMENDATION: I recommend evaluation by a qualified roofing contractor to determine age left on the roof.

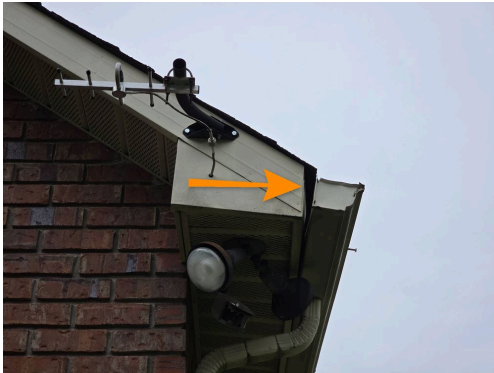
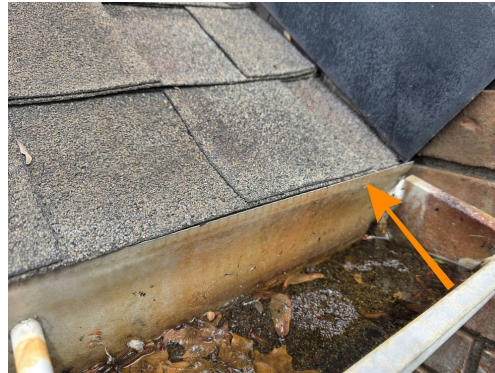
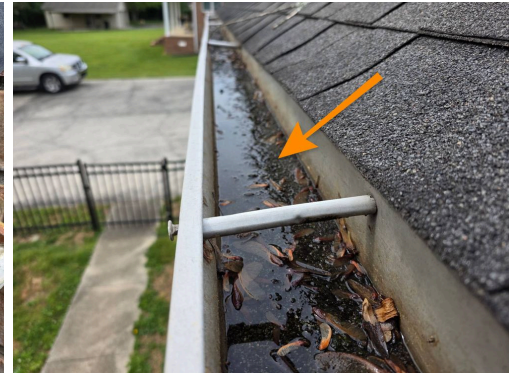
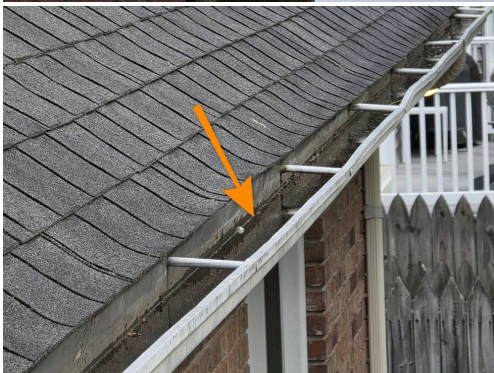
4.4.3 Gutters – Loose and Improperly Positioned

OBSERVATION: The gutter at the front left end of the house was observed coming loose. The gutter along the side of the chimney was installed so that it extends above the front edge of the shingles. Roof/granule debris was also present in all gutters.

EVALUATION: Loose or improperly positioned gutters may not collect and direct roof runoff effectively, and debris buildup can restrict drainage and contribute to overflow.

RECOMMENDATION: I recommend a qualified contractor secure the loose gutter, correct the gutter section that extends above the shingle edge, and clean debris from all gutters to help restore proper drainage.

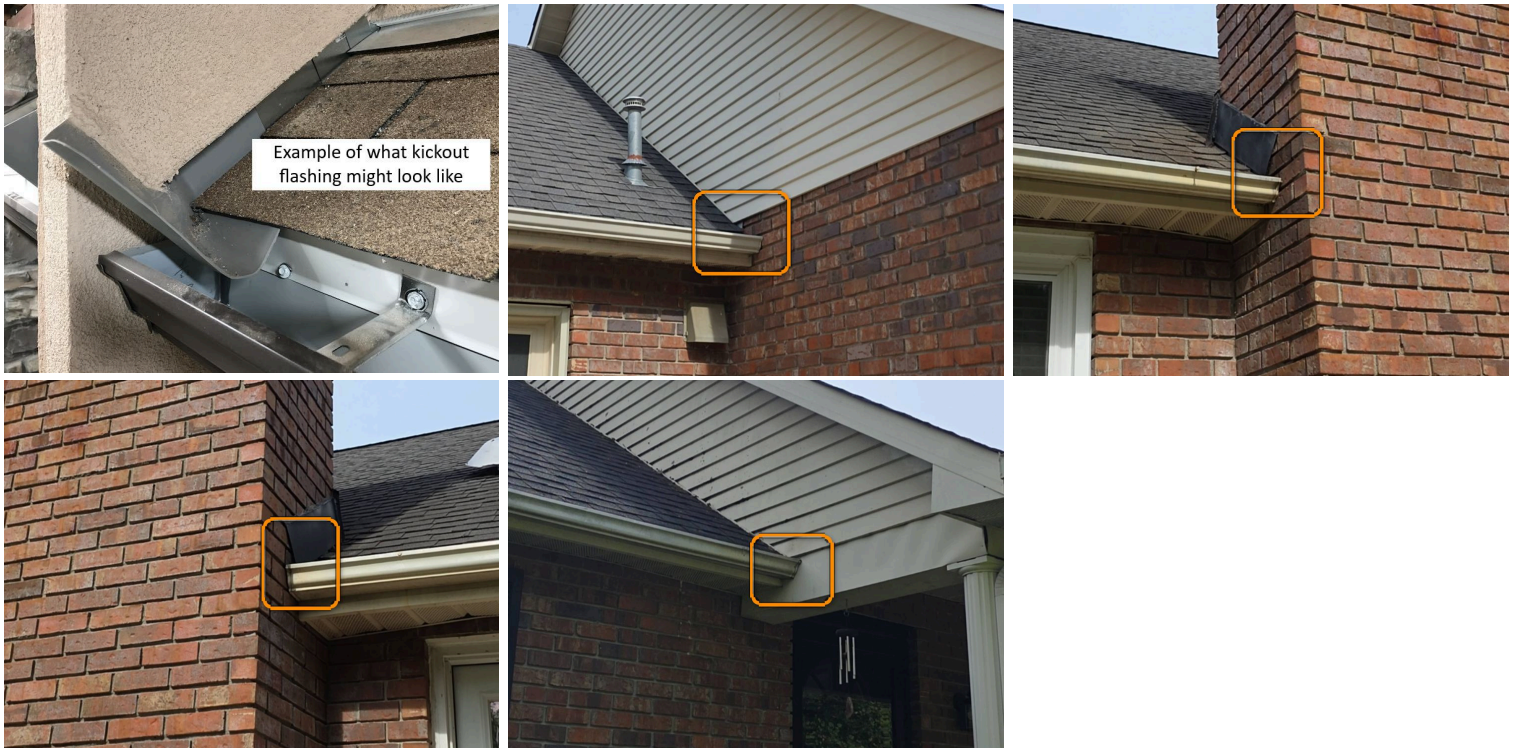
4.5.2 Roof/Wall Kickout Flashing Missing

EVALUATION: This condition can allow roof runoff to discharge directly into the wall area, which may lead to moisture intrusion, concealed damage, and deterioration of adjacent materials.

RECOMMENDATION: Have a qualified roofing contractor install proper kickout flashing at this location to help direct water into the gutter and reduce the risk of water damage.

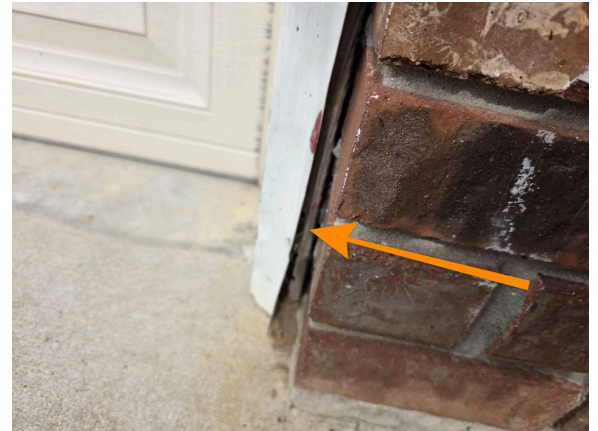
5.1.2 Garage Door Trim – Loose And Deteriorated

OBSERVATION: Metal trim at the right side of the garage door was loose, and exposed wood in this area was visibly deteriorated.

EVALUATION: This condition can allow continued moisture intrusion and further deterioration of the surrounding door framing materials.

RECOMMENDATION: I recommend a qualified contractor repair or replace the loose trim and replace the deteriorated wood as needed.

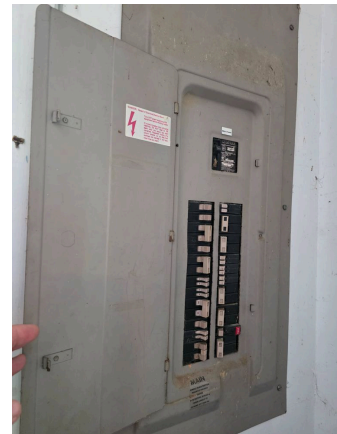
6.4.4 Electrical Panel – No Circuit Labels

EVALUATION: Unlabeled circuits can make it difficult to identify and safely shut off individual breakers during maintenance or an emergency.

RECOMMENDATION: I recommend having a qualified electrician identify the circuits and provide a complete, accurate panel directory.

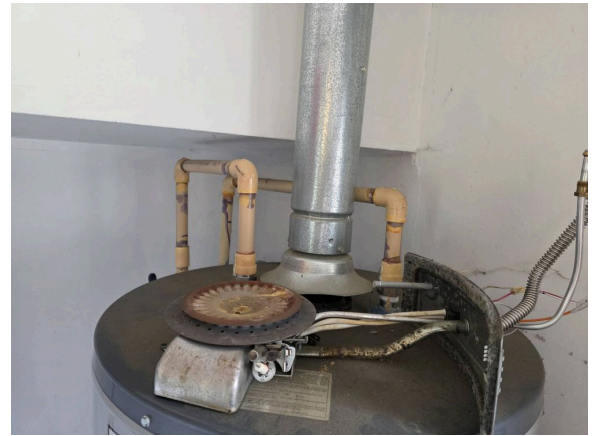
7.1.8 Water Heater - Plastic Piping Too Close

EVALUATION: This condition may expose the piping to excessive heat from the venting system and top of the appliance. Over time, heat exposure can cause the piping to soften, deform, or fail, which could result in leakage or water damage.

RECOMMENDATION: Recommend correction by a qualified plumbing contractor. Piping near the top of the gas water heater should be upgraded or reconfigured with approved materials to provide proper heat resistance and clearance.

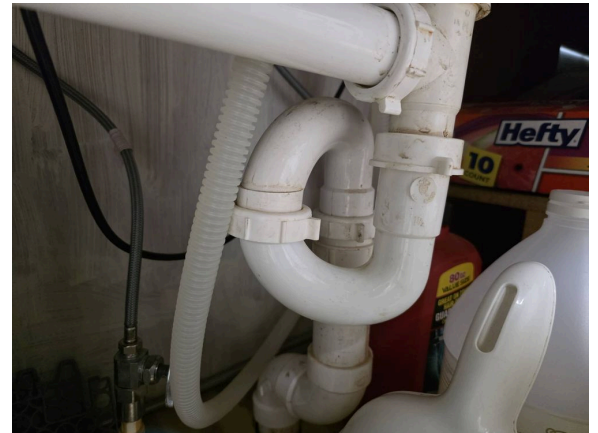
EVALUATION: This type of drain arrangement is not considered a proper modern configuration and can allow the trap to siphon dry, which may permit sewer gases to enter the home. Improper drain piping can also affect drainage performance.

RECOMMENDATION: Recommend correction of the drain piping by a *qualified plumbing contractor* to provide a proper trap and vented configuration.

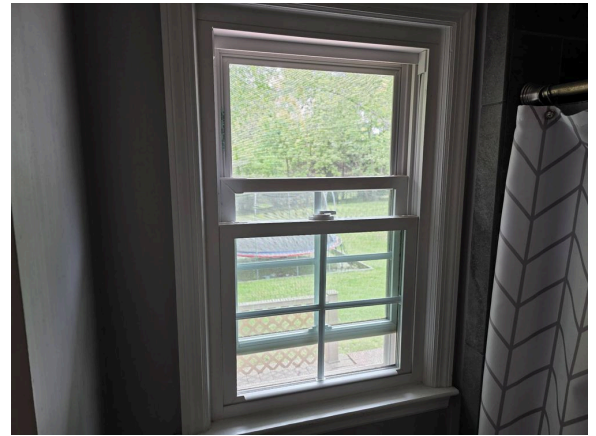
EVALUATION: This indicates a defective window sash balance or related hardware, which can affect normal operation and may create a safety concern.

RECOMMENDATION: I recommend repair by a qualified contractor to restore proper window function.

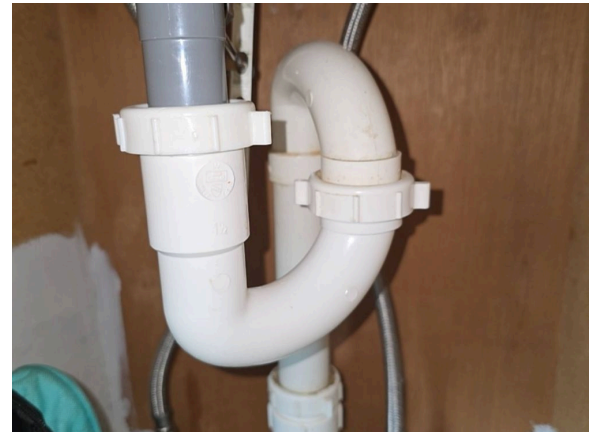
EVALUATION: S-traps are not considered current standard because they can allow the water seal to siphon out, which may permit sewer gases to enter the home.

RECOMMENDATION: I recommend correction by a qualified plumbing contractor.

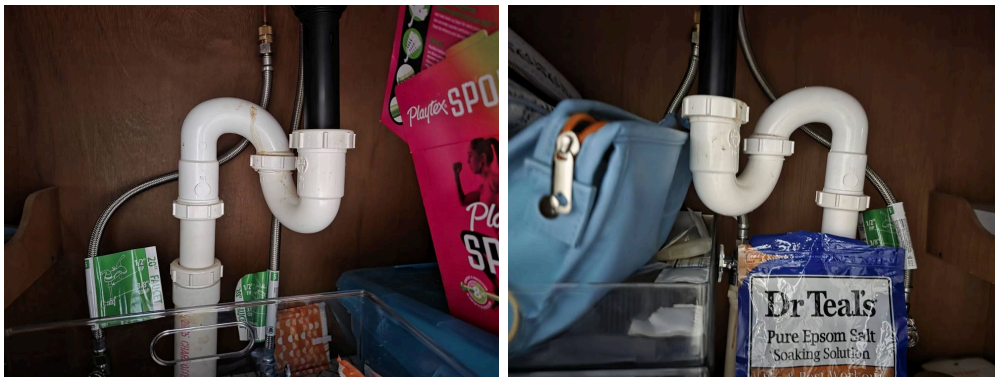
EVALUATION: S-traps are not considered current standard because they can allow the water seal to siphon out, which may permit sewer gases to enter the home.

RECOMMENDATION: I recommend correction by a qualified plumbing contractor.

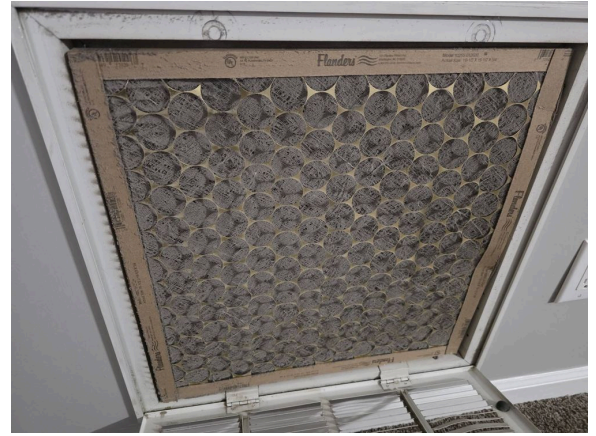
EVALUATION: Restricted airflow from dirty filters can reduce system efficiency and may contribute to unnecessary wear on HVAC components.

Upstairs

RECOMMENDATION: I recommend replacing the dirty filter(s) and continuing to change them at regular intervals in accordance with the manufacturer's guidance.

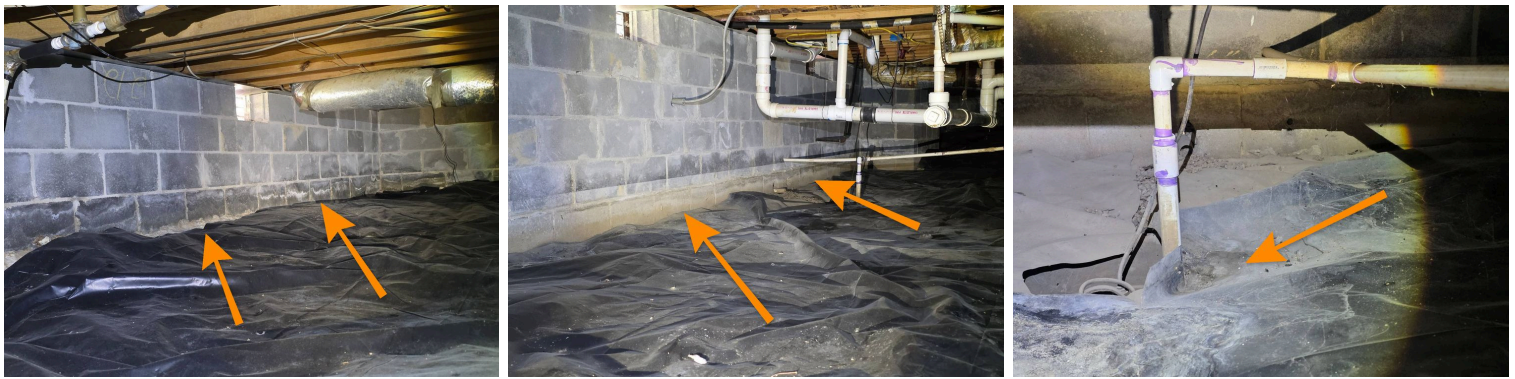
EVALUATION: Crawlspace moisture conditions can vary based on drainage, grading, ventilation, and vapor barrier coverage, and elevated moisture can contribute to mold growth and deterioration of structural materials over time.

RECOMMENDATION: I recommend evaluation by a qualified contractor, with improvements, upgrades, or repairs made as needed to help control crawlspace moisture and maintain a dry, stable environment around the home's foundation.

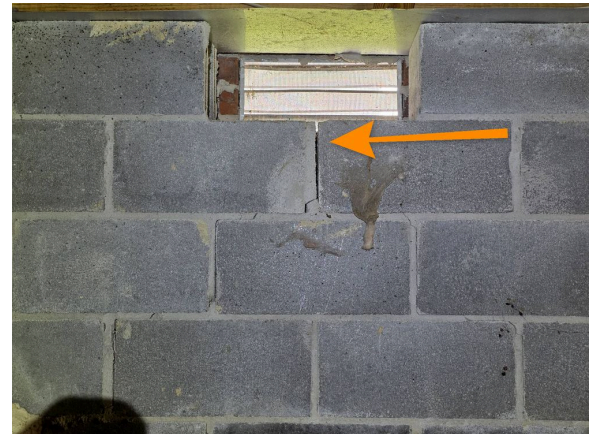
EVALUATION: Foundation wall cracks can indicate movement or allow moisture intrusion, and further evaluation is needed to determine the significance of this condition.

Left end of home

RECOMMENDATION: I recommend evaluation by a qualified contractor or foundation specialist to determine whether repair is needed.
